Sinking of the landing craft/barge “1473” with the loss of one life between Barbuda and Antigua on 26th February, 2015.

This casualty investigation was conducted by the Antigua and Barbuda Defense Force Coastguard and the Antigua and Barbuda Department of Marine Services and Merchant Shipping (ADOMS).

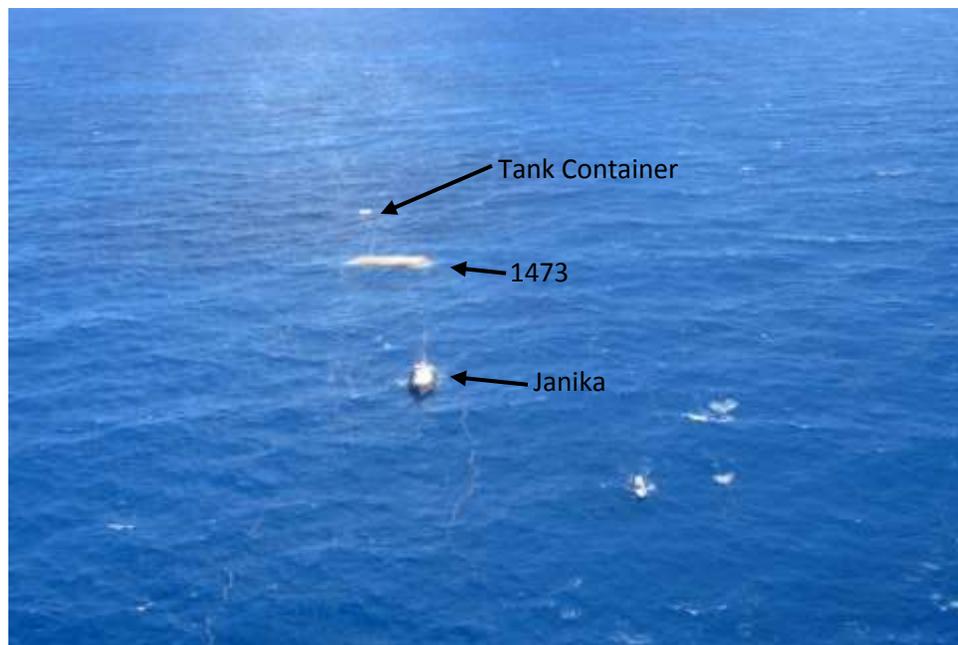
Figure 2: Janika towing Capsized “1473” and Empty Fuel Tank Container
Photo: Greg Scott – Caribben Helicopters

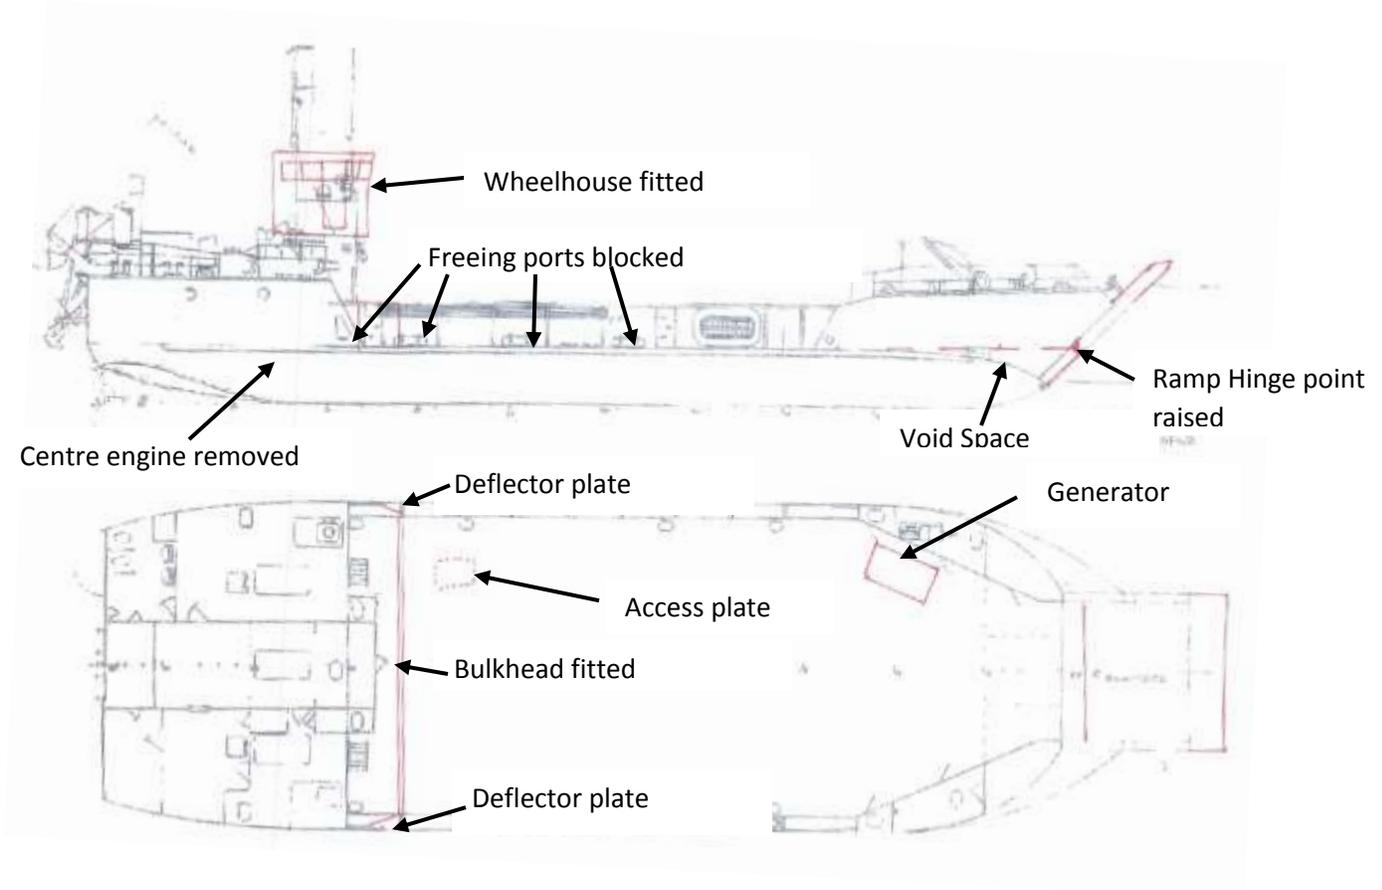
2.1.1.2 The wheelhouse had been modified at some stage and the military equipment removed. Annex 1 shows pictures of a similar vessel. The bow ramp arrangement had been modified to raise the effective threshold and this had created an additional void space under the cargo deck forward .The

- 2.1.1.3 In order to carry sand most of the freeing ports at the sides of cargo deck had been covered and also a temporary bullhead had been placed across the cargo deck about 1.5 meters forward of the accommodation block, creating an area which would not have cargo in it but also appears to have very minimal drainage as modifications had also been made to deflect water off the side decks in front of the accommodation block which also obstructed the original water freeing arrangements in this area.

- 2.1.1.4 New accesses had been cut into the cargo deck and one of these in the aft port side area appears to have not been secured, which will have contributed to water entering the hull and also to the eventual sinking as after capsizing the cover plate will have fallen off giving a good entry point for water into the hull with air probably being vented out through the original fixed bilge pumping piping system.

Figure 5: Main Modifications to “1473” – shown in red

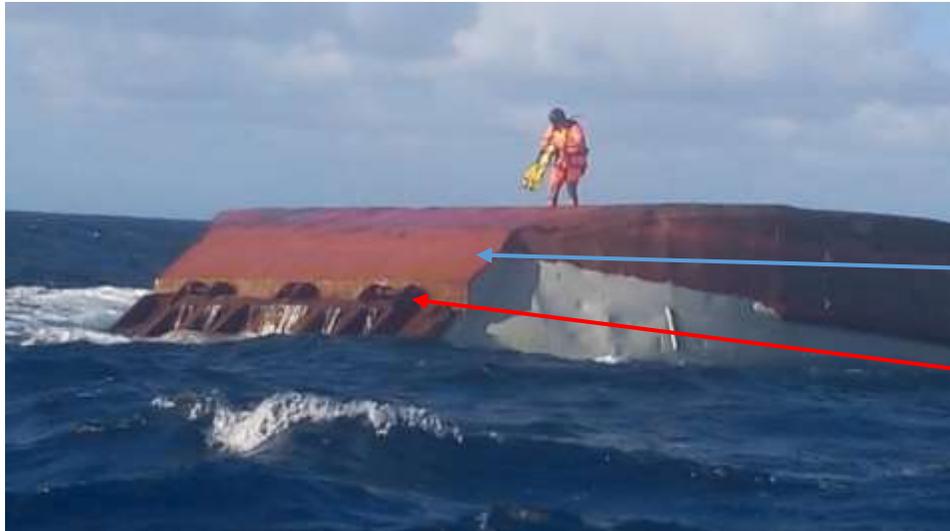
Modified area of bow to raise hinge level

Figure 6: The bow part of “1473” clearly showing the modifications to bow ramp and also indicating that buoyancy has been retained in that portion of the vessel whilst inverted.
Photo: MRCC Forte de France

- 2.2.14 When inverted the vessel maintained a reasonable "freeboard" and this indicates that there was probably not a large amount of water in the main tanks at the time of capsizing. The aft section of the vessel would quickly flood due to the hatches and doors being open. The dive survey showed that these were not dogged down and also revealed that there was an access hole to the main hull void which although likely to have been covered when the vessel was upright became open upon capsizing and this together with air probably venting out through the original fixed bilge piping system would have led to the slow sinking of the vessel.

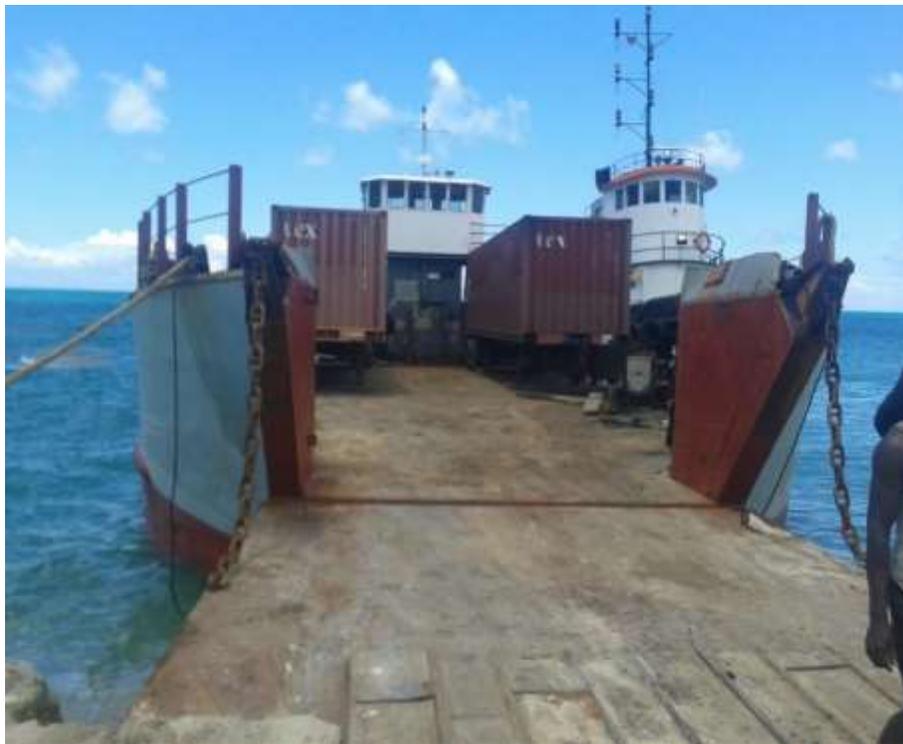
Figure 7: “1473” on a previous voyage showing the bow ramp arrangement
Photo: Owner

windward side (port side) this would result in the windward side of the cargo becoming wet with the water absorbed by the sand and leading to an increase in weight on the port side which in turn reduces the effective freeboard and thus of course increases the amount of spray being shipped. There would also be some ingress of water onto cargo deck through the bow door opening as when raised the ramp did not completely seal this opening.

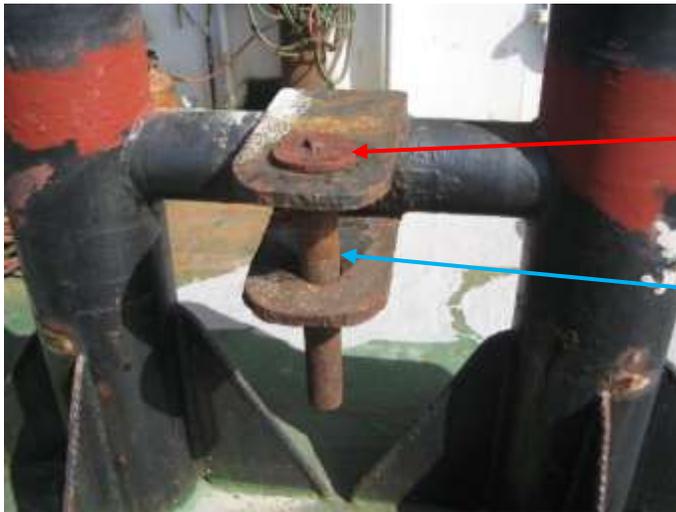
2.1.2.2 Janika had been updated over the years but still has many original features. One modification which is of significance with respect to this casualty is that the towing arrangement had been modified to include a pin arrangement which did not have a quick release facility.

Figure 9: The towing pin mounted on the original towing bits.
Photo: ADOMS

- The Owner is recommended that he only uses appropriately loaded fit for purpose vessels for conducting transportation activities at sea and reviews the towing arrangements utilized.

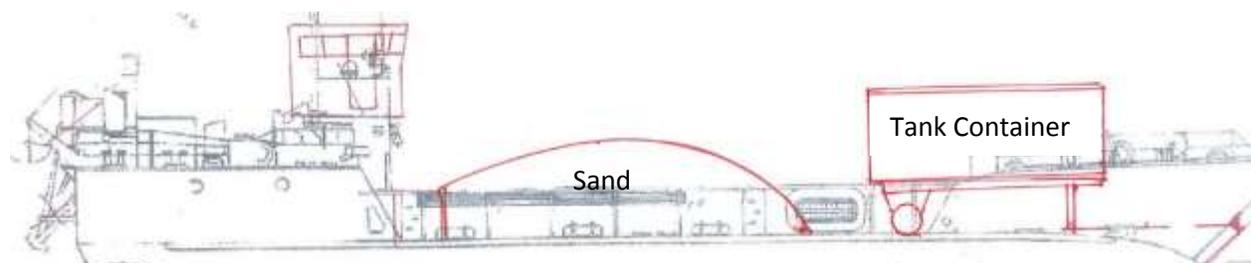
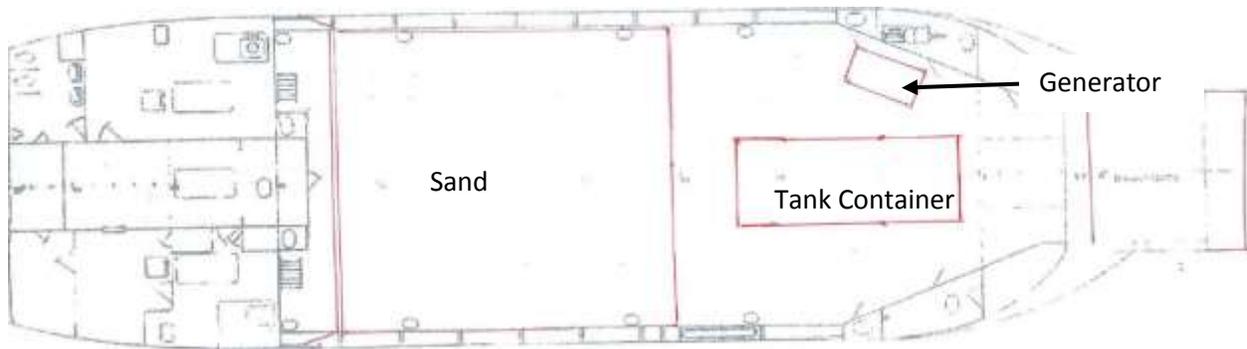
Figure 13: Approximate cargo plan

- 2.4.2.1 The sand cargo is believed to have been reasonably dry with a density of approximately 1630 kg m^{-3} which with maximum moisture content was found to increase to 1850 kg m^{-3} which is a mass increase of some 13.5%
- 2.4.2.2 The IMO International Maritime Solid Bulk Cargoes Code describes sand as a group C cargo which is not liable to liquefy during transport. However it recommends that the cargo should be kept dry and trimmed reasonably level. In this case of course the sand was neither kept dry nor had it been trimmed level.

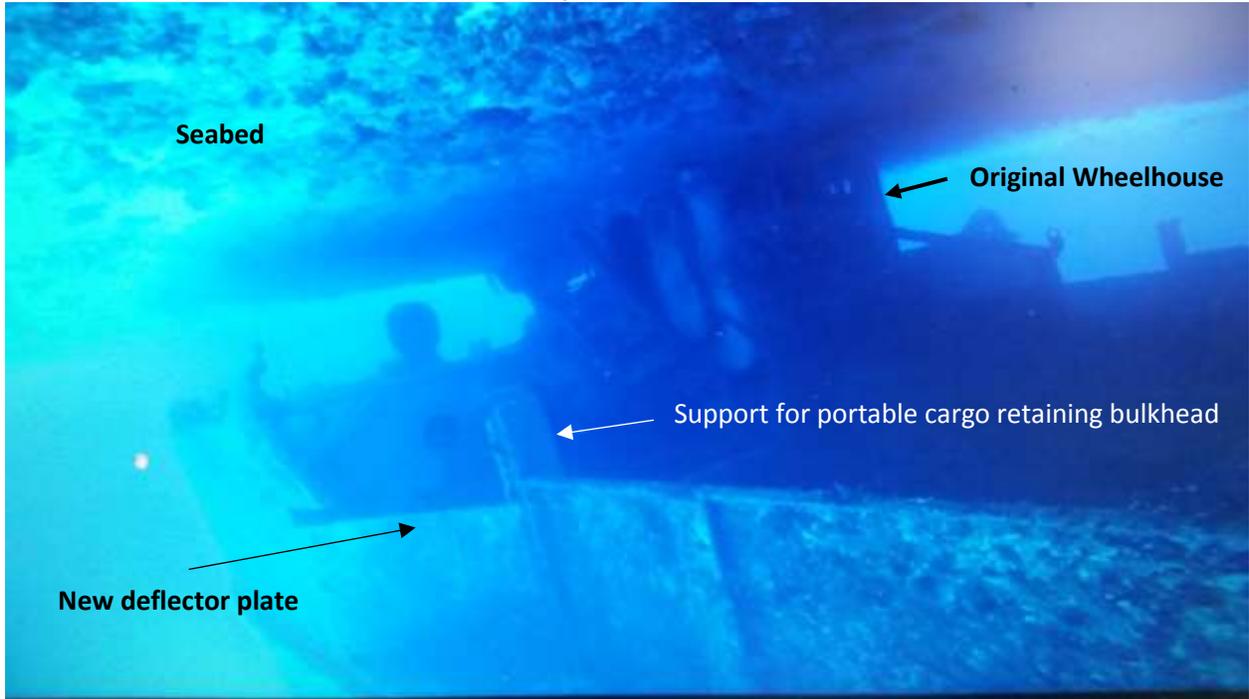
Aft Part of the wreck – photo inverted – Photo: Eli Fuller

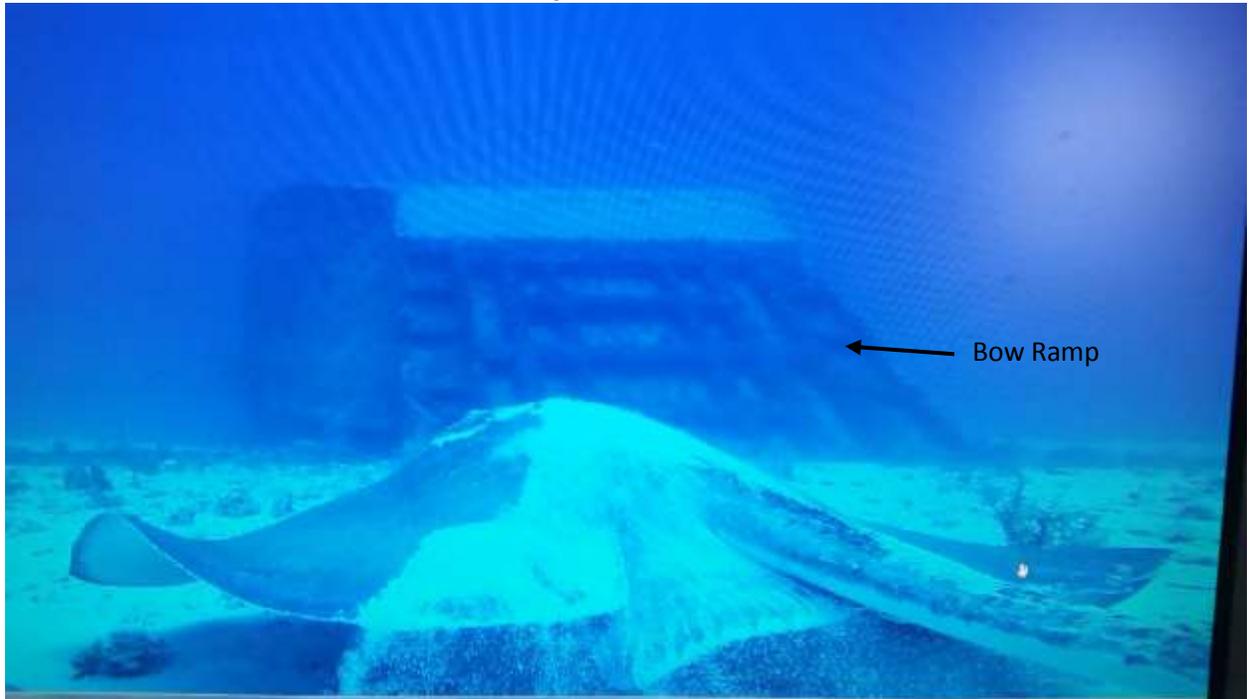
The Wreck from ahead showing bow ramp still in place – Photo: Eli Fuller

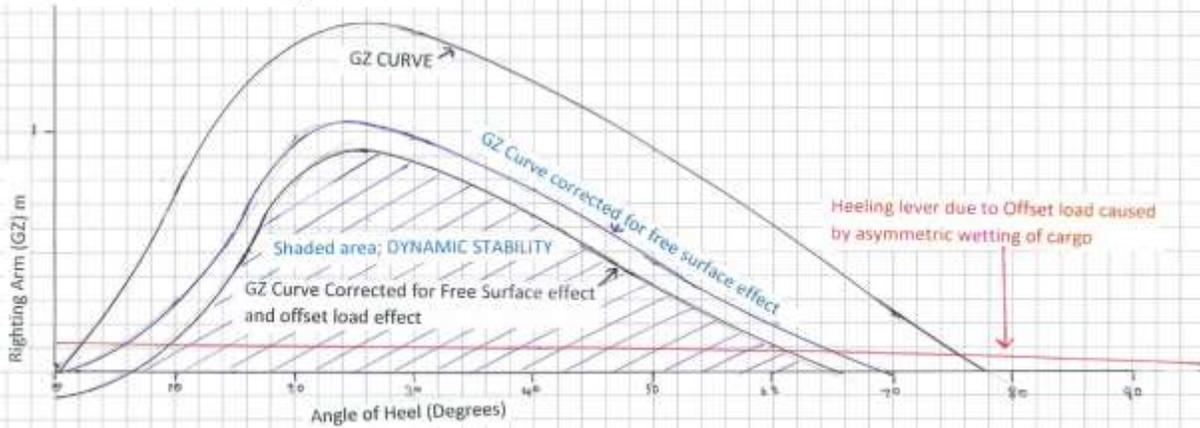
Diagram 3

Estimated as loaded GZ curve for condition at time of capsize showing reduced GZ caused by free surface effect and also the offset load effect which led to the vessel heeling and further reduced effective GZ and reserve of dynamic stability

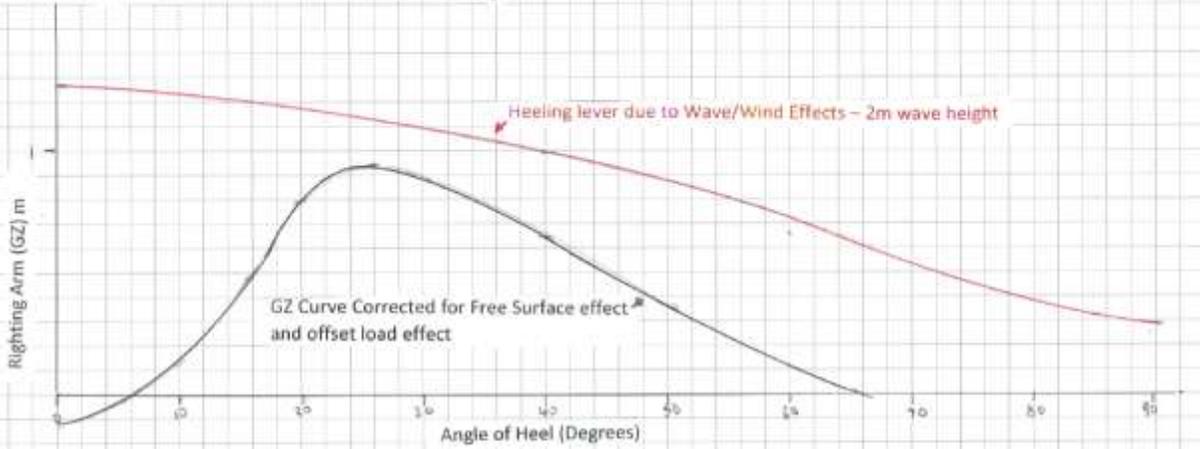
Diagram 4

Estimated as loaded GZ curve for condition at time of capsize showing maximum level of 2m high waves significantly exceeds righting lever and thus removes reserve of dynamic stability.
