Casualty Incident Report

Safety investigation into the collision involving the St Kitts & Nevis registered high speed craft **LOVELY 1** and the Antigua & Barbuda registered passenger catamaran **ONE LOVE**, in St John's harbor Antigua, on 31 October 2017.

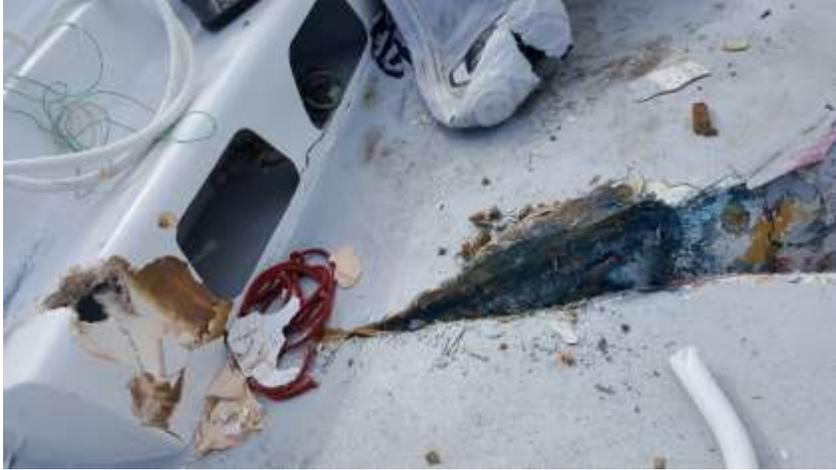
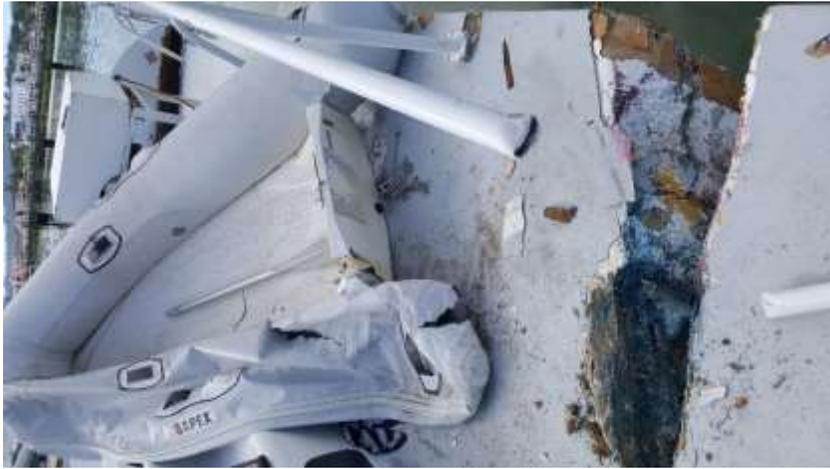
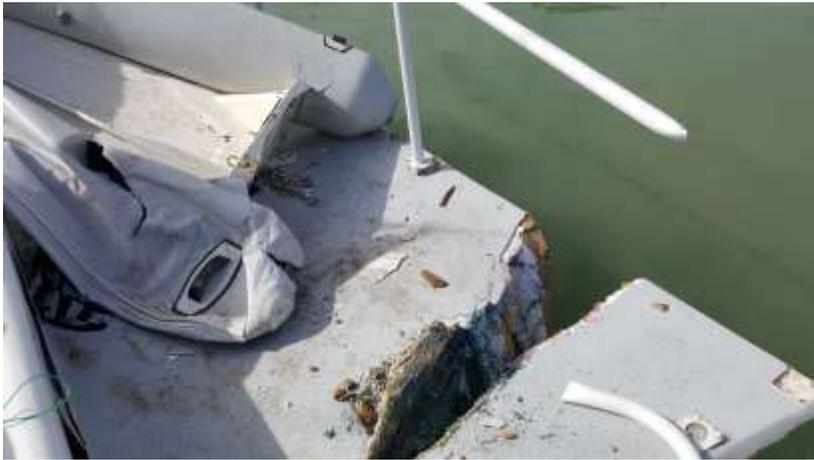
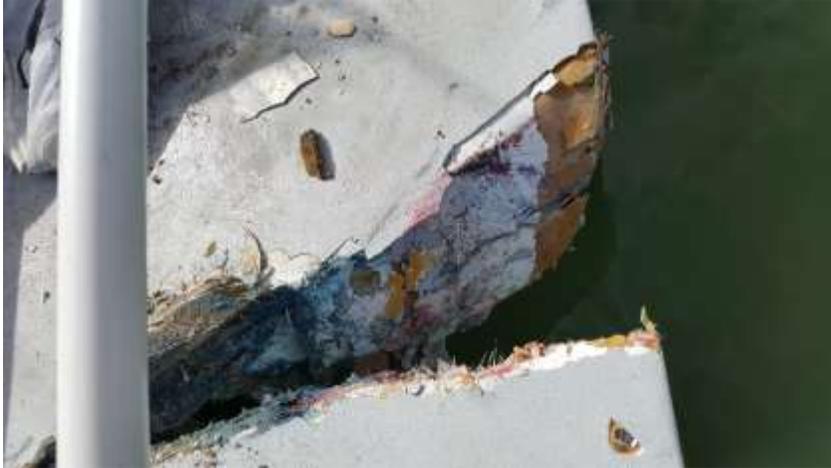
The One Love sustained considerable structural damage to the stern leading to partial flooding of aft compartment, but there was minimal damage to Lovely 1.

There was damage to the port bow and considerable damage to the stern of One Love, but only minor damage to starboard hull of Lovely 1.

The damage to One Love resulted in flooding of the port aft compartment and the high level bilge alarm and pump activated and assistance with the salvage came later from maintenance support crew from North Sound Marina.

The extensive damage to One Love was noted (see photographs).

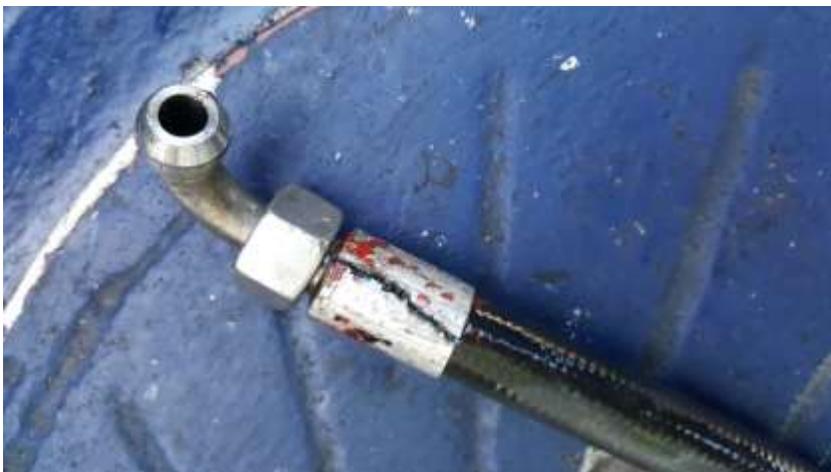
Upon investigation the Chief Engineer of Lovely 1 discovered that the steering failure stemmed from a ruptured hydraulic hose on the port side steering bucket of the water jet.

All of the hydraulic oil had leaked out, rendering the steering bucket inoperative.

The Chief Engineer indicated the ruptured port hydraulic hose (see photograph) and the renewed hose was sighted.

3.2 The steering failure was due to a ruptured hydraulic hose serving the port steering bucket of the water jet.

A new hydraulic hose was fitted and Lovely 1 manoeuvred away and berthed back at the Monserrat ferry berth, at Heritage Quay.

5.1 The owners of Lovely 1 to closely monitor the condition of hydraulic hoses during future operations.

Chief Engineer to routinely check seals and hydraulic pressure, particularly during close space manoeuvring.

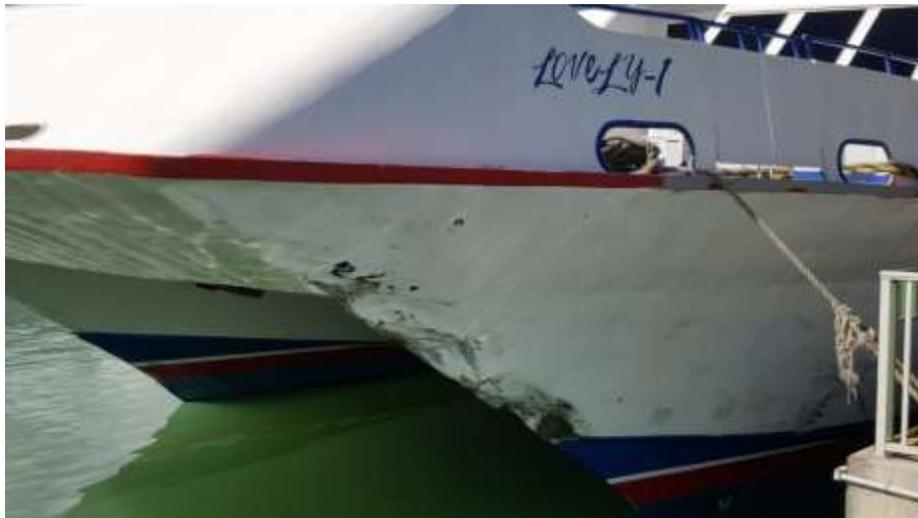
A targeted Port State Control (PSC) inspection of Lovely 1 revealed extensive damage to the port bow (see section 4 Other Findings below).

The Master advised that the noted port bow damage was unrelated to the collision incident and was due to a previous electrical relay fault.

On 2 October 2017 the Lovely 1 had collided with the pier in Portsmouth harbor Dominica, after steering failure in this case, due to damaged electrical relays.

The cause of previous damage to port bow of Lovely 1 on 2 October 2017 needs to be established, as a separate steering failure.

A detailed report from the attending electrical engineer is to be provided by owners, to clearly indicate and explain the damage to the electrical relays.
