Sinking of the landing craft/barge “1473” with the loss of one life between Barbuda and Antigua on 26th February, 2015.

This casualty investigation was conducted by the Antigua and Barbuda Defense Force Coastguard and the Antigua and Barbuda Department of Marine Services and Merchant Shipping (ADOMS).

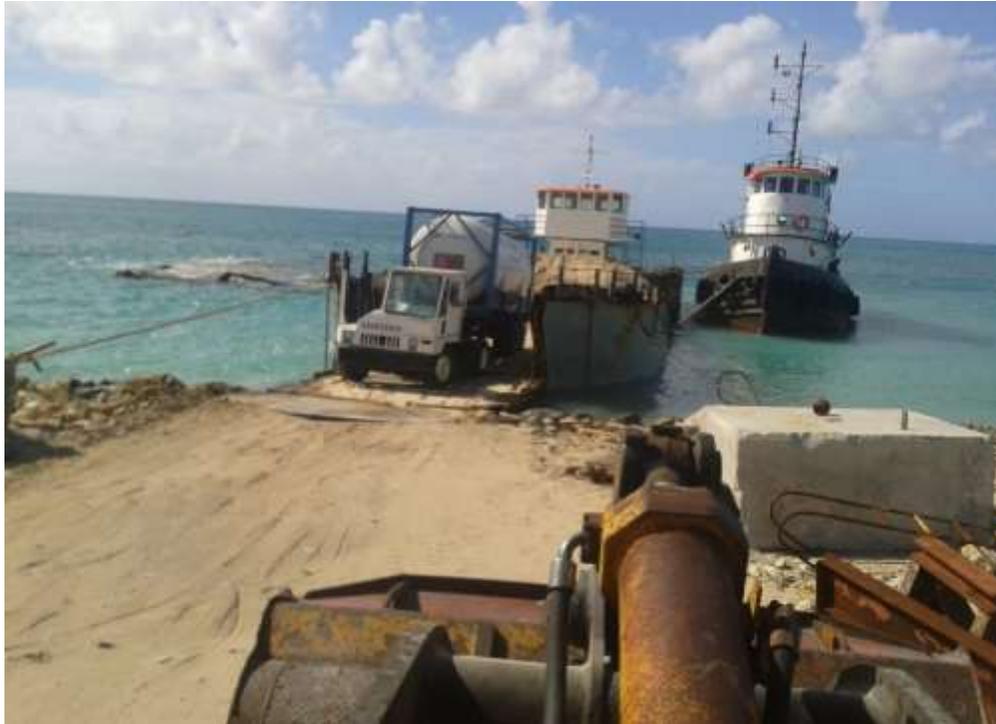
Figure 1: “1473” Loading Cargo in Barbuda

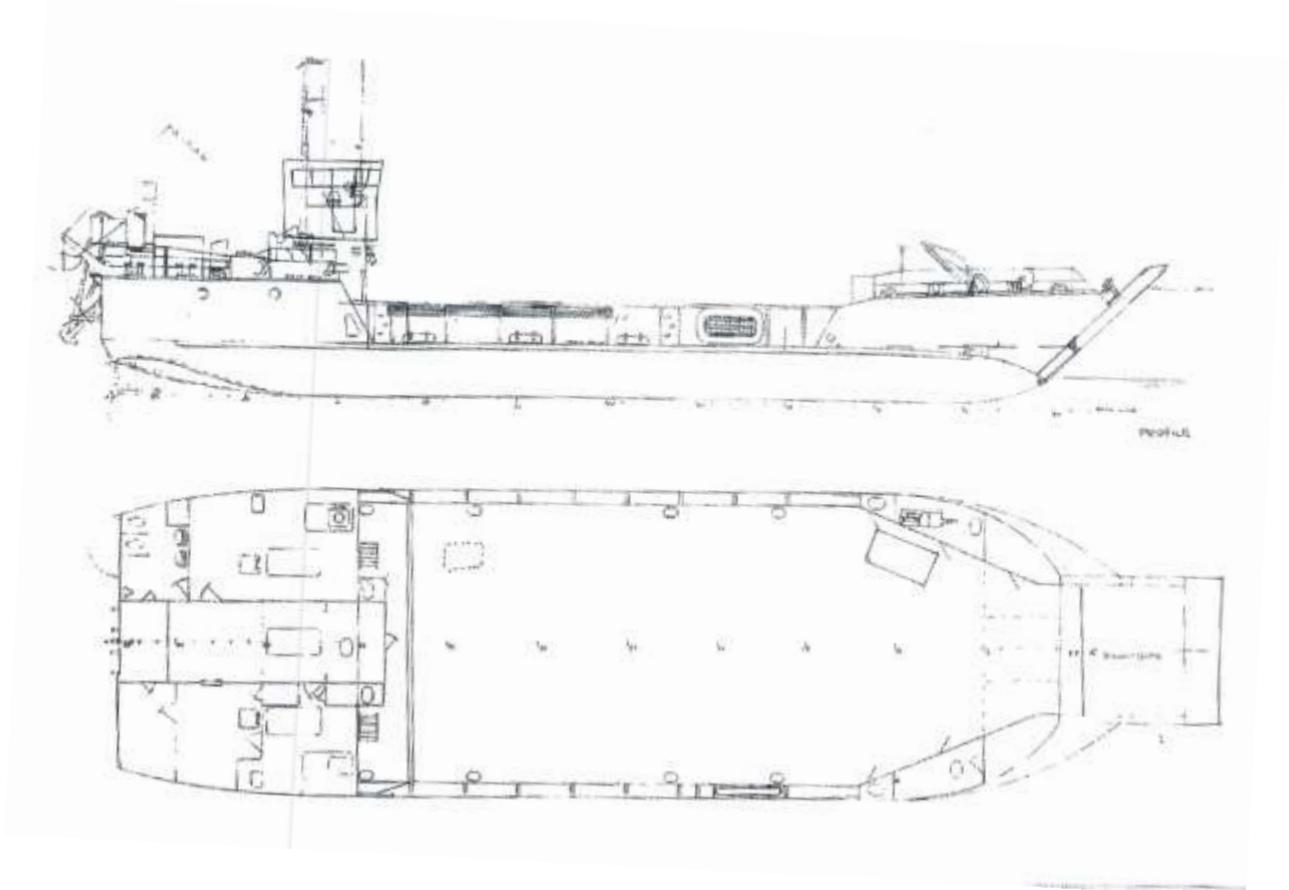
Figure 4 General arrangement plan of this type of landing craft

2.1.1.1 The vessel was originally designed as a landing craft for carrying wheeled and tracked vehicles with triple engine propulsion. The vessel is believed to have been built as LCU 1473 by the Island Dockyard for the United States Navy and delivered in 1953. It was one of the LCU -1466 Class

centre engine had been removed so in general these modifications will have led to a decrease in the trim in lightship condition.

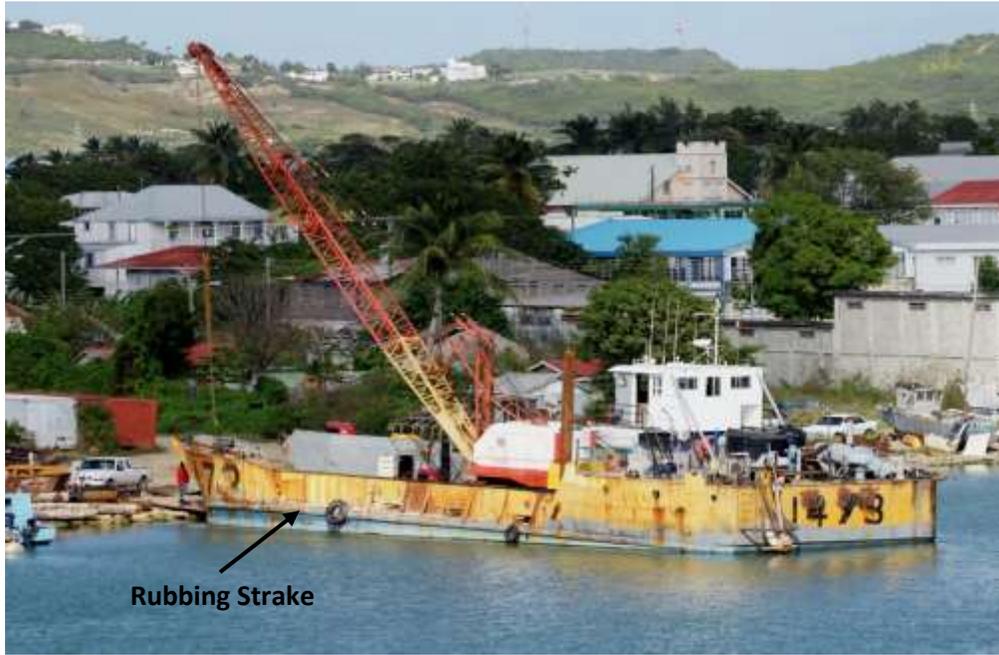
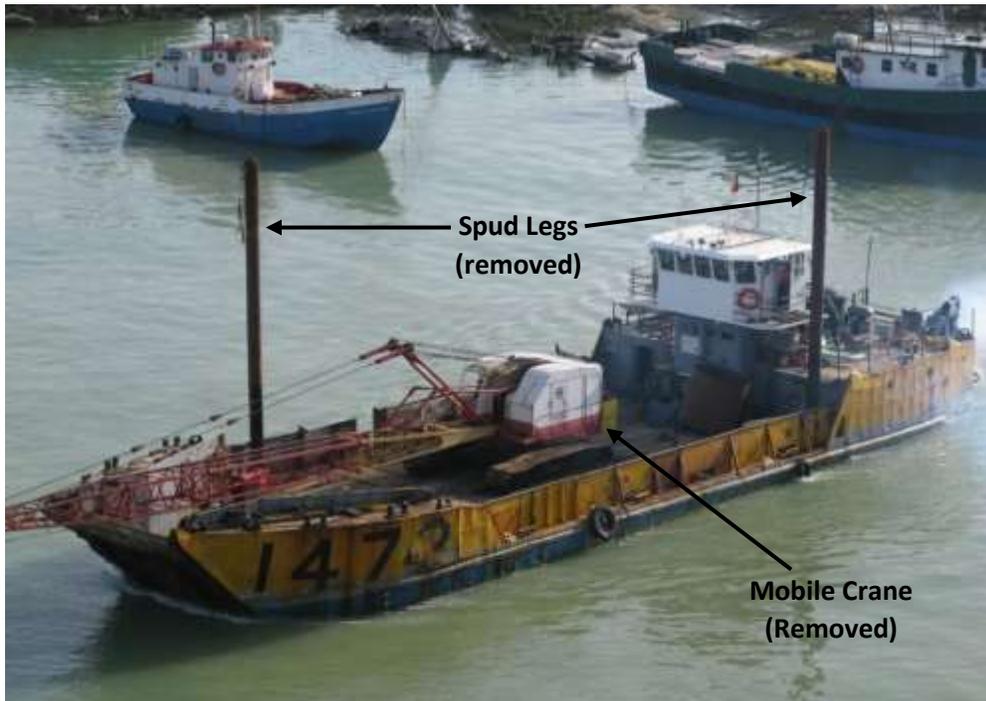
Annex 2: “1473” In use in St John’s Harbour with spud legs and mobile crane on board (both since removed)
