Casualty Incident Report

Safety investigation into the collision involving the St Kitts & Nevis registered high speed craft **LOVELY 1** and the Antigua & Barbuda registered passenger catamaran **ONE LOVE**, in St John's harbor Antigua, on 31 October 2017.

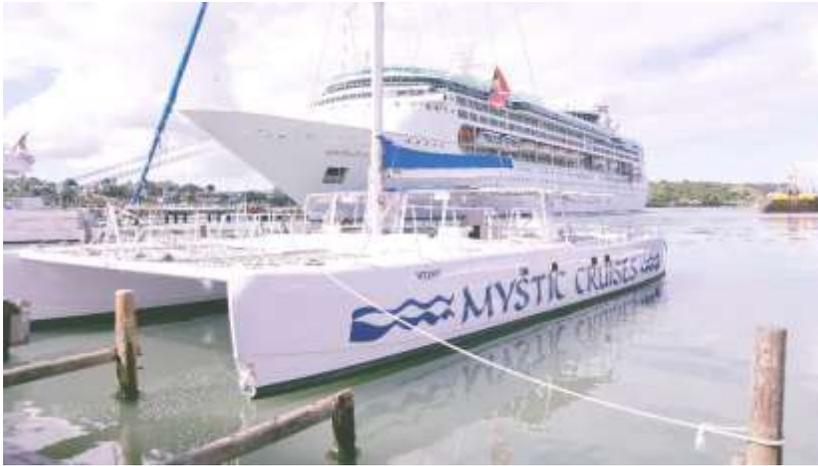
ONE LOVE

The One Love sustained considerable structural damage to the stern leading to partial flooding of aft compartment, but there was minimal damage to Lovely 1.

There was damage to the port bow and considerable damage to the stern of One Love, but only minor damage to starboard hull of Lovely 1.

The damage to One Love resulted in flooding of the port aft compartment and the high level bilge alarm and pump activated and assistance with the salvage came later from maintenance support crew from North Sound Marina.

The extensive damage to One Love was noted (see photographs).

Statements were taken from Ms Pia Baptiste (General Manager) and Mr Noel Jackson (Operations Manager) of operator Tropical Adventures Antigua. The One Love was then towed away to North Sound Marina boatyard for repair.

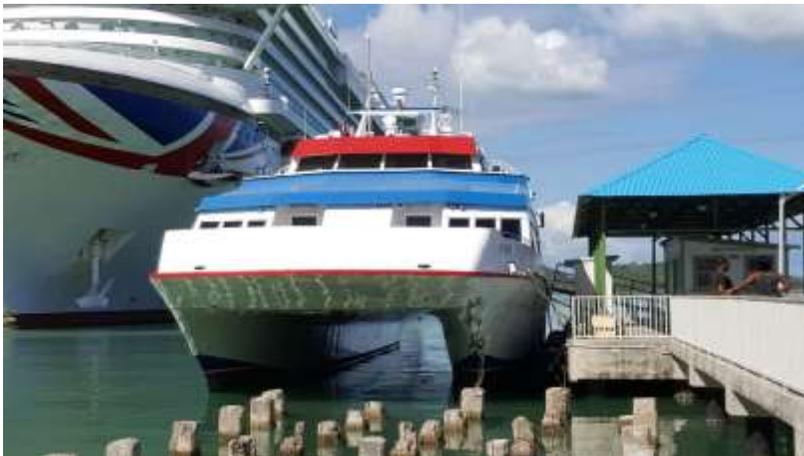
LOVELY 1

Antigua Department of Marine Services (ADOMS) Technical Department concluded that the immediate cause of the collision was steering failure of the Lovely 1, due to a ruptured hydraulic hose, on the port side steering bucket water jet.

Upon investigation the Chief Engineer of Lovely 1 discovered that the steering failure stemmed from a ruptured hydraulic hose on the port side steering bucket of the water jet.

All of the hydraulic oil had leaked out, rendering the steering bucket inoperative.

A targeted Port State Control (PSC) inspection of Lovely 1 revealed extensive damage to the port bow (see section 4 Other Findings below).

The Master advised that the noted port bow damage was unrelated to the collision incident and was due to a previous electrical relay fault.

On 2 October 2017 the Lovely 1 had collided with the pier in Portsmouth harbor Dominica, after steering failure in this case, due to damaged electrical relays.

5.1 The owners of Lovely 1 to closely monitor the condition of hydraulic hoses during future operations.
